Manhole Inspection Summary

Manhole # S19U__006MH

Location Address: **GWYNNS FALLS TRAIL**

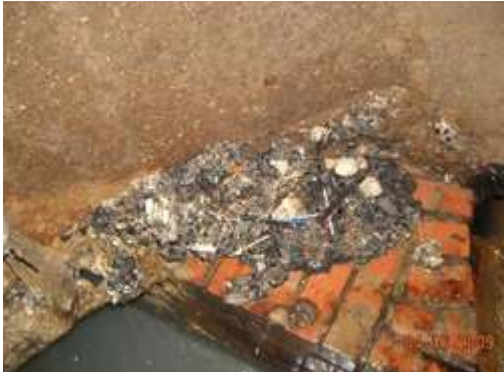
Miscellaneous

DEBRIS ON BENCH

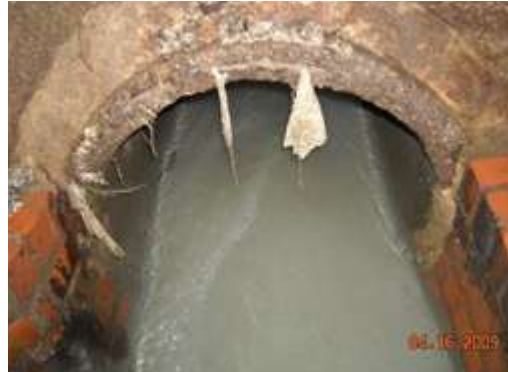
Defect 6

Surcharge ☒ **Evidence Of Surcharge** Depth: **4** (ft.) ☐ Active Surcharge Present

EVIDENCE OF SURCHARGE

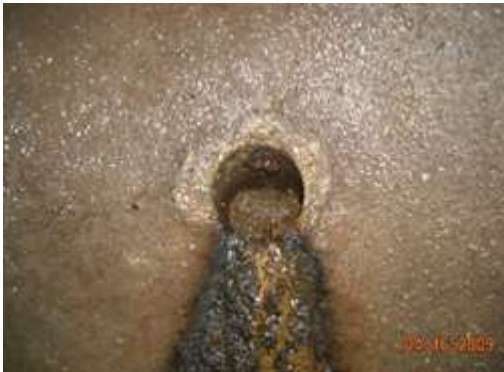
Defect 4

Infiltration: ☐ None ☐ Joint ☐ Cracks ☐ Mortar ☐ Roots ☒ **Wall**

INFILTRATION @ CORBEL WALL
LIFTING HOLE

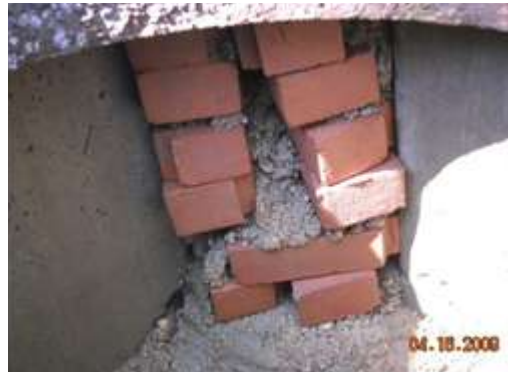
Defect 3

Condition: ☐ Sound ☒ **Cracked** ☐ Root Intrusion ☒ **Loose Brick** ☐ Deteriorated

LOOSE BRICKS IN CHIMNEY GAP

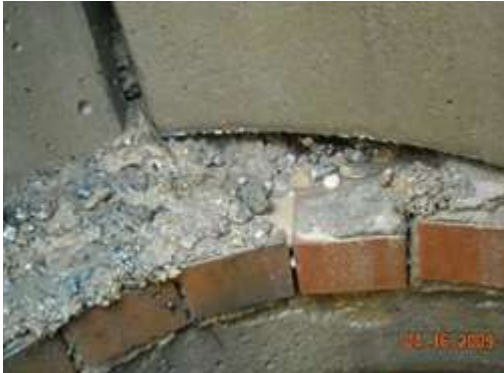
Defect 2

Infiltration: ☐ None ☐ Joint ☒ **Cracks** ☐ Mortar ☐ Roots ☐ Wall

INFILTRATION FROM CHIMNEY GAP

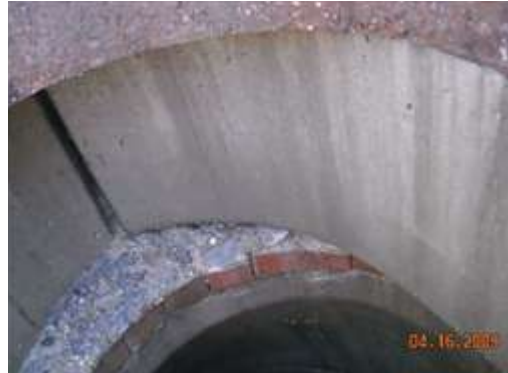
Defect 1

OPEN GAP BETWEEN PRECAST
CHIMNEY PIECES

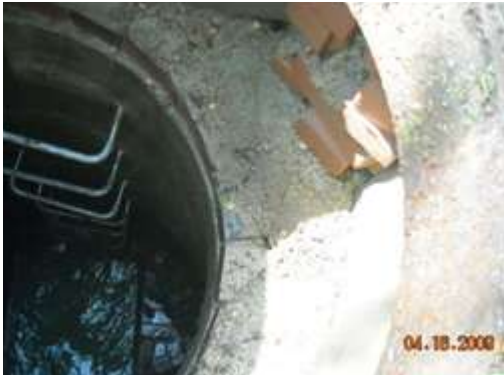
Defect 7

Frame Offset: **6** (in.) Condition: ☒ Sound ☐ Cracked ☐ Leaks

CHIMNEY/CORBEL OFFSET OF 6
INCHES

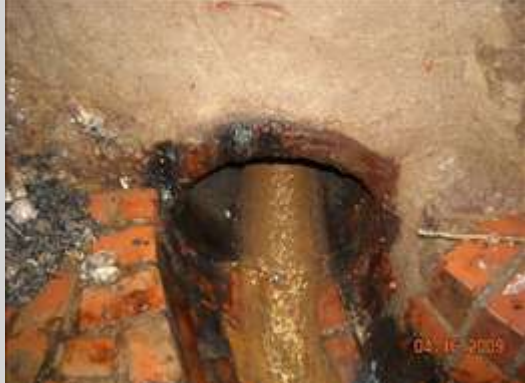
9 O'Clock Inflow

Infiltration: **Weeper** Pipe Seal Cond: **Sound**
